March 3, 2011

40S-1501 VG Leg 3:1 Retro Kit

VG Leg 3:1 VG Retro Kit

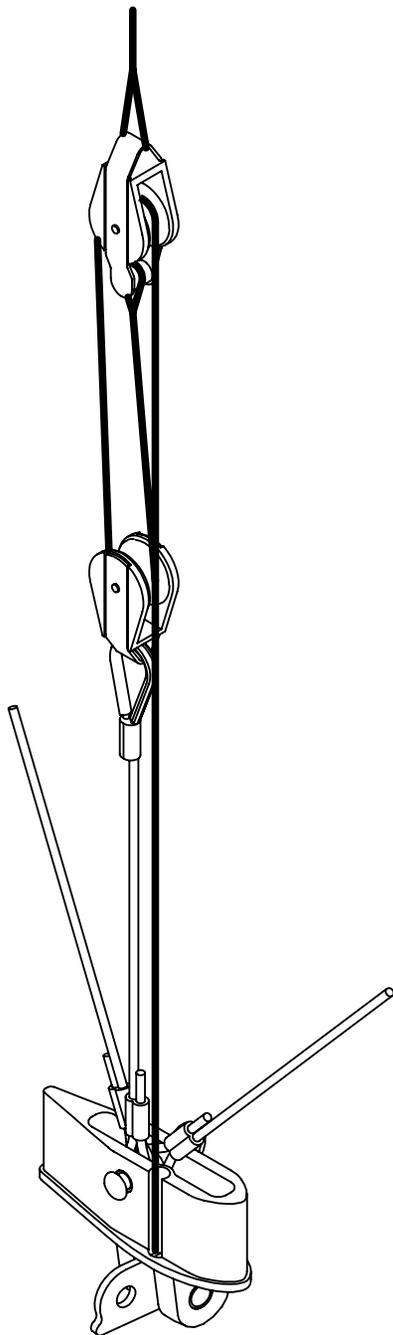
6. Refer to the diagram for the proper orientation of the pulleys and cord routing
7. Check that the knot that secures the VG cord to the upper pulley becket is secure

8. Displace the sleeve that secures the front to rear wires enough to install the lower pulley cable loop then move the sleeve back into position
9. Check that the order of the cables (1) pulley anchor - outside (2) bottom rear - middle (3) bottom front - inside

10. Feed the loose end of the VG cord 6 inches through the lower downtube fitting and secure with an overhand knot
11. Pull the new VG system into the downtube with the old VG cord making sure that the orientation of the pulleys is correct and not twisted

12. Replace the bottom control bar plug, clevis pin and safety
13. Tie the upper VG system to the top pulley with a secure bowline knot in the same position as the previous knot
